# **Navajo Abandoned Uranium Mine**

## **Site Screen Report**

### **Julius Chee No. 2 AUM Site**

#### **Navajo AUM Western Region**

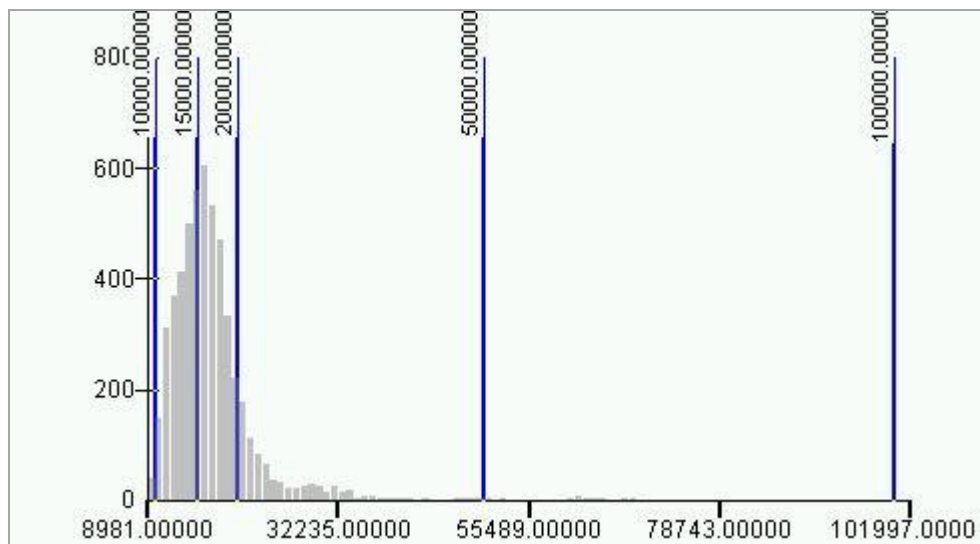
**Mine ID:** 158

A total of 5,278 gamma radiation measurements were collected from the mine site, ranging from 8,981 cpm to 101,997 cpm. The measurements are represented in Figures 1 and 2.

The following chart and statistics were generated by ESRI ArcGIS 9.3.1, and show the general distribution of the site gamma radiation measurements. The horizontal X axis represents the gamma radiation reading levels in cpm (lowest levels to the left). The vertical Y axis represents the frequency of each gamma radiation level.

Count:	5278
Minimum:	8981.00000
Maximum:	101997.00000
Sum:	89588970.00000
Mean:	16974.03751
Median:	15983.00000
Standard Deviation:	6307.36200

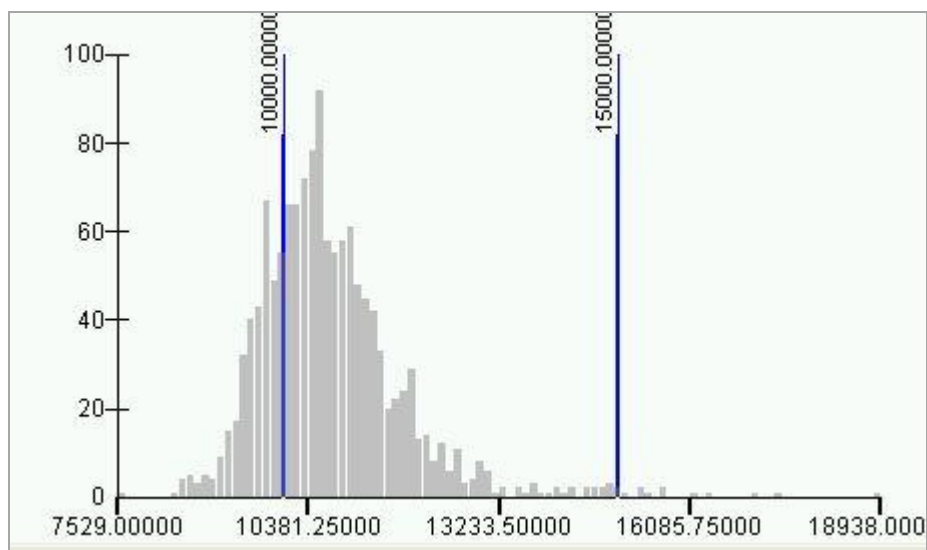
**Mine ID:** 1041

A total of 1,342 gamma radiation measurements were collected from the mine site, ranging from 7,529 cpm to 19,938 cpm. The measurements are represented in Figures 1 and 2.

The following chart and statistics were generated by ESRI ArcGIS 9.3.1, and show the general distribution of the site gamma radiation measurements. The horizontal X axis represents the gamma radiation reading levels in cpm (lowest levels to the left). The vertical Y axis represents the frequency of each gamma radiation level.

Count:	1342
Minimum:	7529.00000
Maximum:	18938.00000
Sum:	14376842.00000
Mean:	10712.99702
Median:	10546.50000
Standard Deviation:	1111.76543

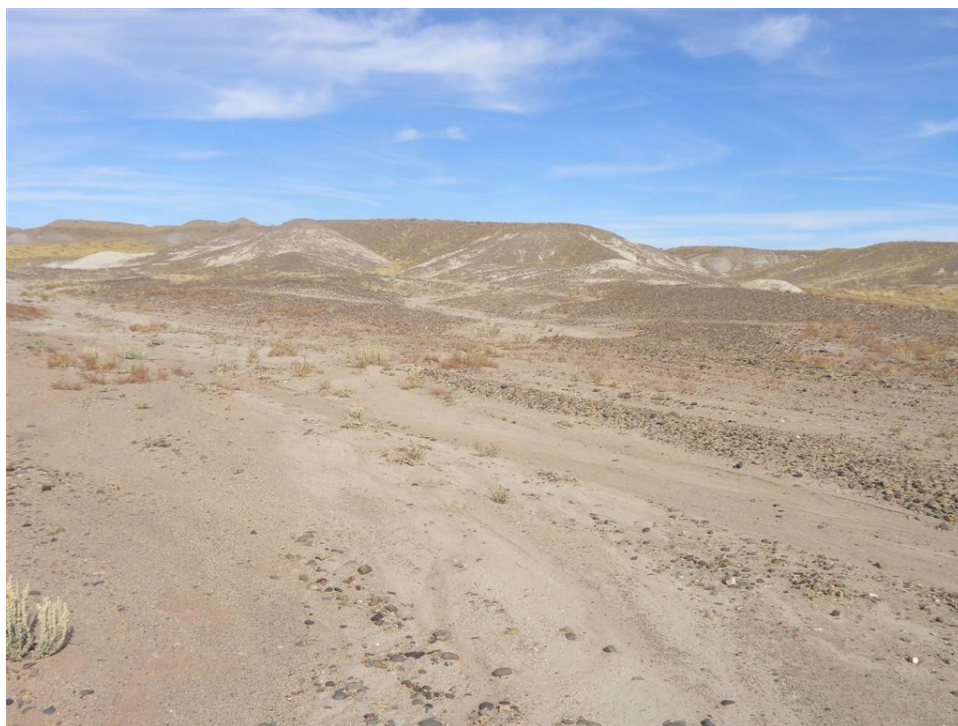
2 large reclamation caps, possibly connected, positioned in central valley area

Photo 1. Julius Chee No. 2, Site #158, reclamation area

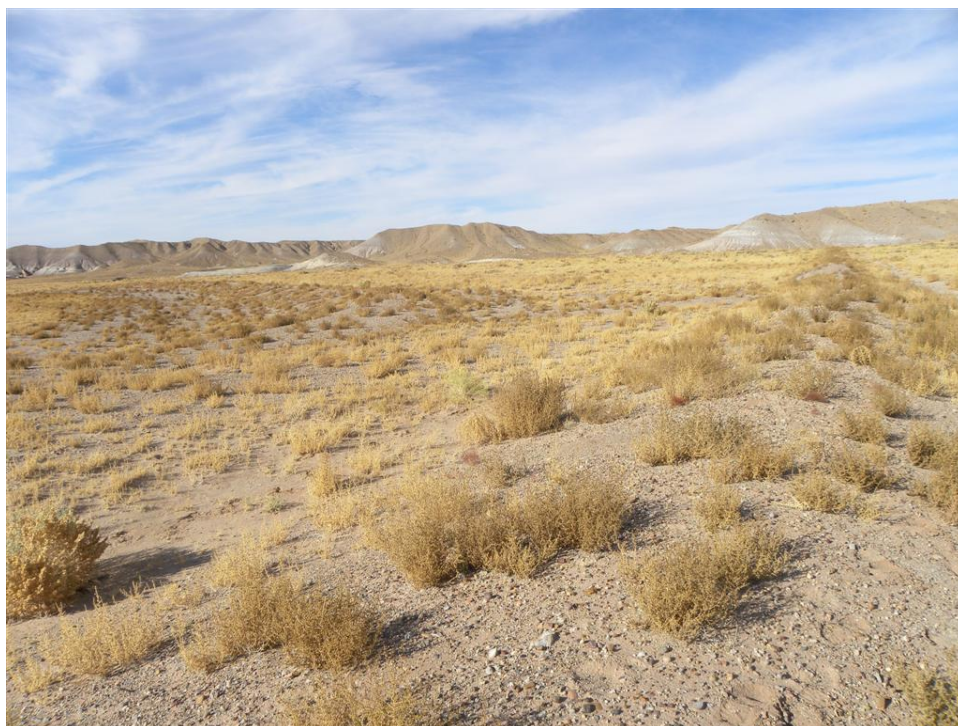
Photo 2. Julius Chee No. 2, Site #1041

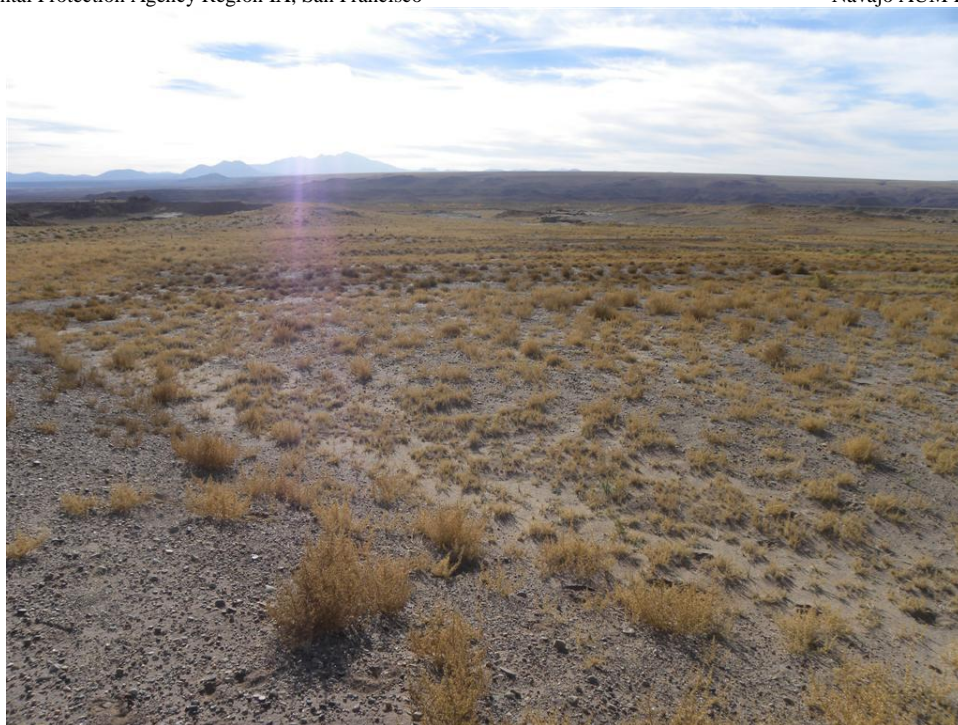
Series of reclamation berms over area identified on old topo maps as "tailings", berms cover the corner area between sites 159, 549, 550, and 1041, breached in the southwest

Photo 3. Julius Chee No. 2, Site #1041, reclamation berm area

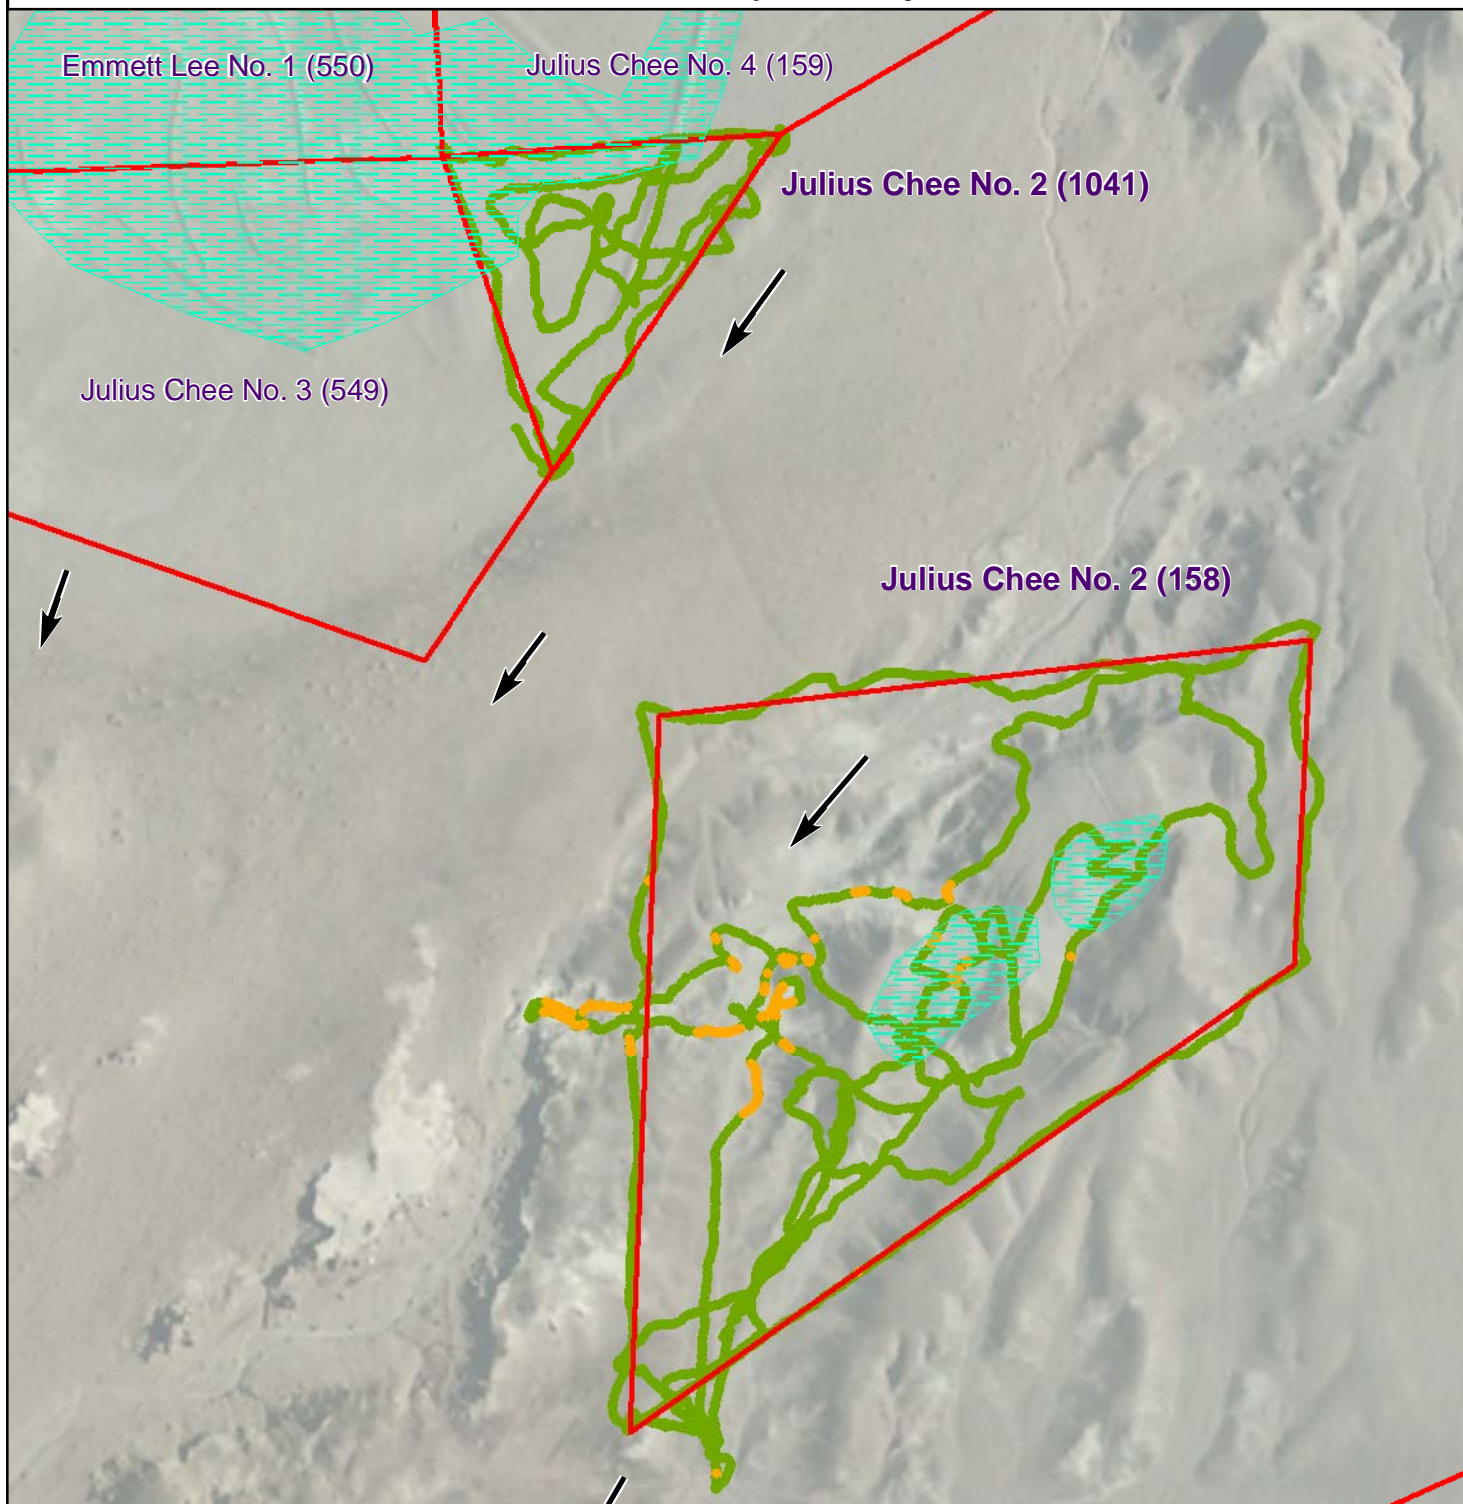
**Figure 1 - Gamma Radiation Measurements, Above Two Times Background  
Julius Chee No. 2 (158, 1041)  
Coalmine Mesa Chapter, Navajo Nation**

Gamma survey conducted 11/2010  
Measured as counts per minute (cpm)

Average background 12,328 cpm

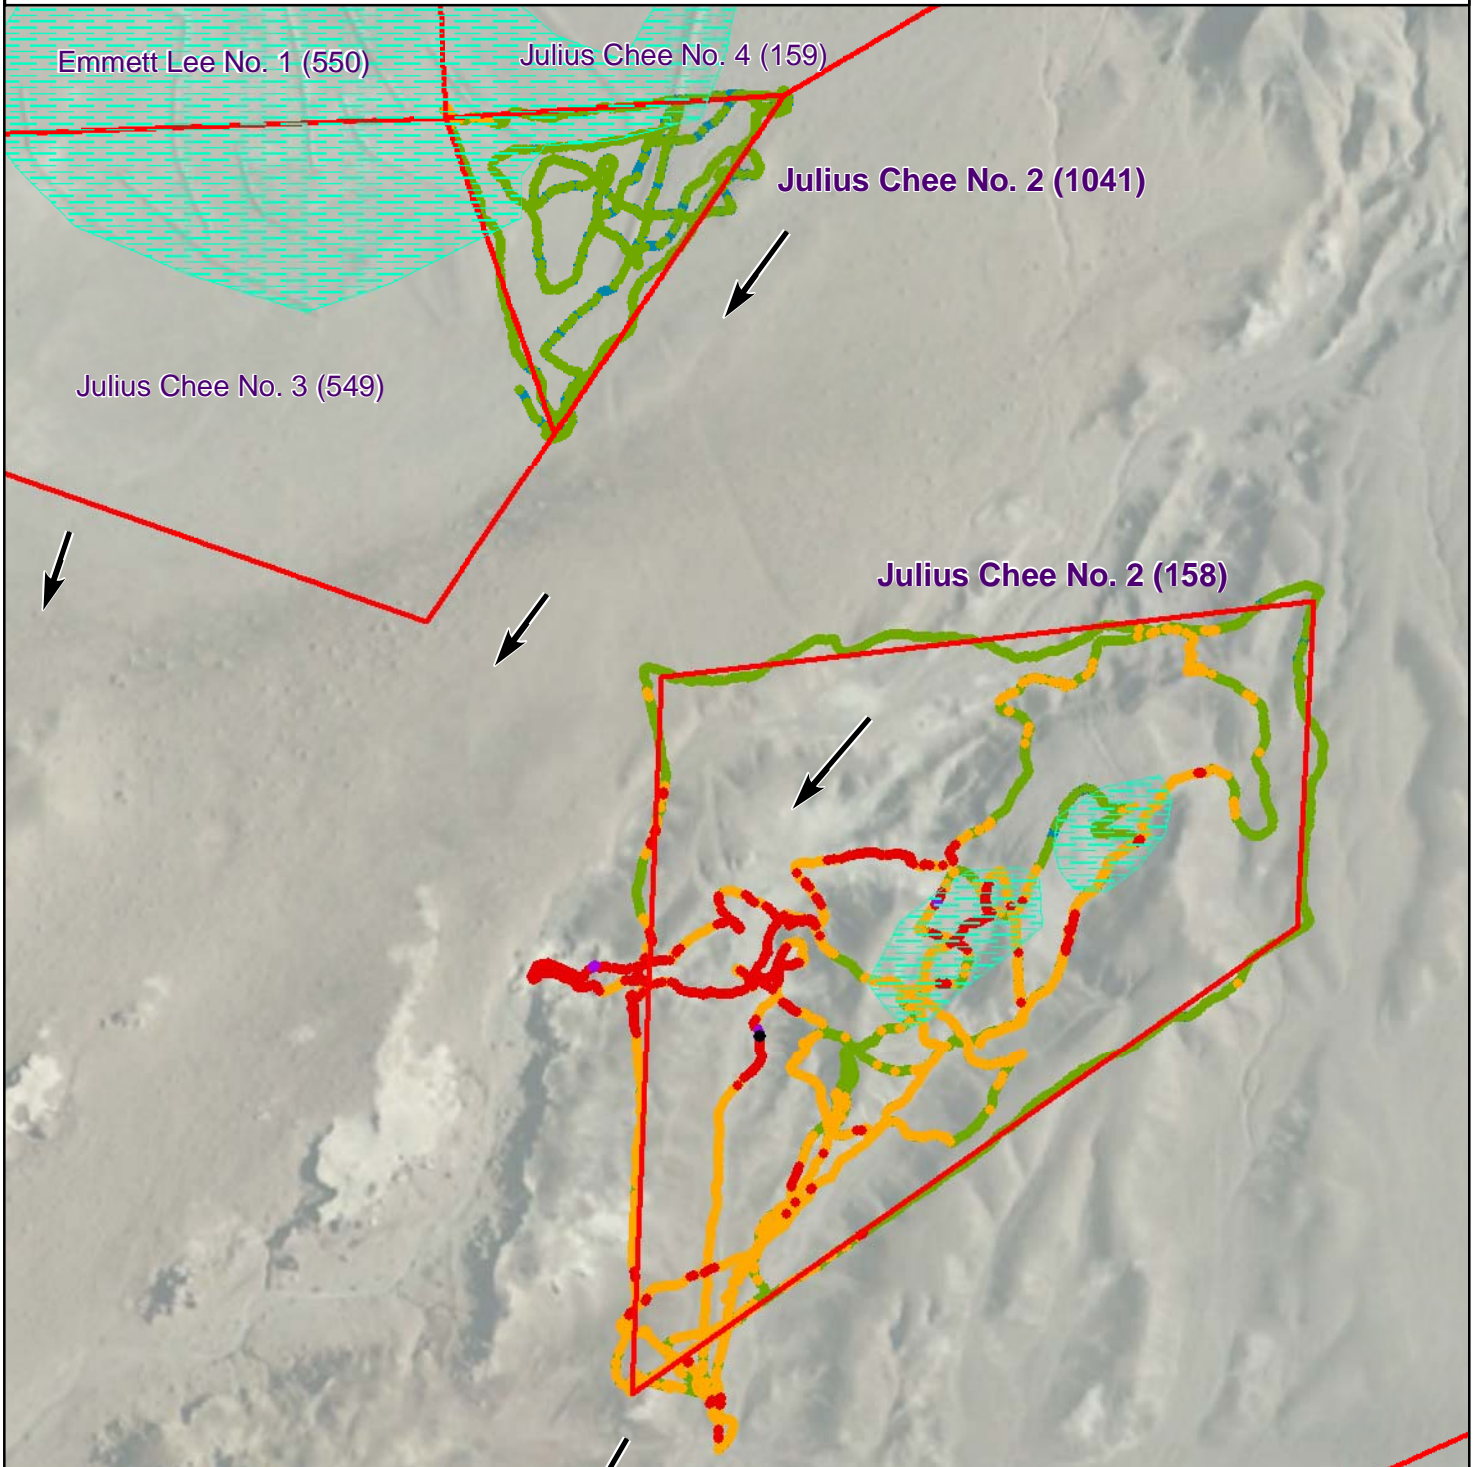
**Figure 2 - Gamma Radiation Measurements**  
**Julius Chee No. 2 (158, 1041)**  
**Coalmine Mesa Chapter, Navajo Nation**

**Gamma survey conducted 11/2010**  
**Measured as counts per minute (cpm)**

**Average background 12,328 cpm**
